Yu. Posypaiko^{1,*}, A. Andreev²

Monitoring the technical condition of the fuel storage facility at the Ukrainian Antarctic Akademik Vernadsky station

3.1 General characteristics and technical conditions of the VST-200 fuel tank

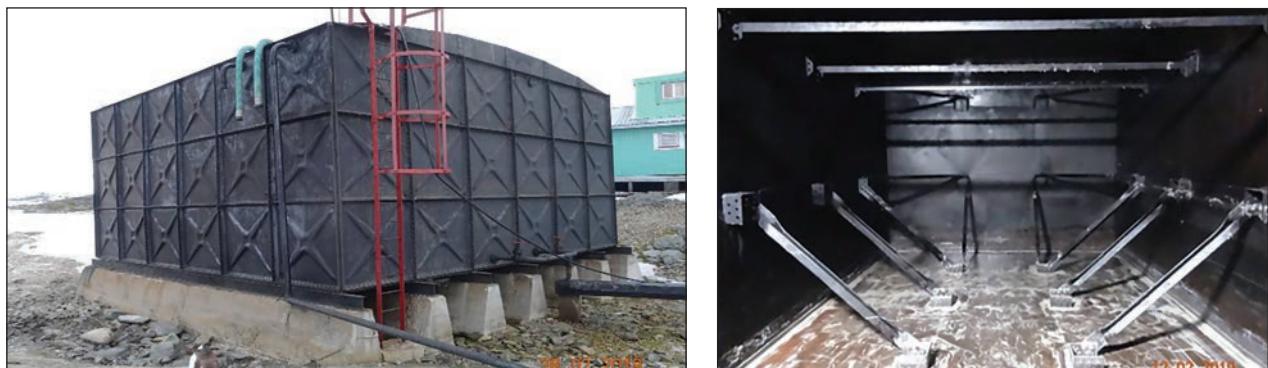
Figure 2. The decommissioned old fuel tank HST-150, outside and inside view

In response to the 2008 Agreement for Bilateral Cooperation in Antarctica between the State Institution National Antarctic Scientific Center and the British Antarctic Survey, the old fuel tank HST-150 was taken out of service. The waste fuel and sludge were carefully removed in a special container without causing pollution from the Antarctic Treaty Area and then utilized properly following the provisions of the Protocol on Environmental Protection to the Antarctic Treaty, as well as recommendations of the inspections carried out under the Antarctic Treaty (ATCM, 1999; 2005). Due to financial and technical difficulties in demolishing and removing the old fuel storage facility, the decommissioned fuel tank HST-150 is modified to a dry solid materials store by fitting a door in a side wall, as it has already been done with another smaller old fuel storage tank with a capacity of 33 m^3 (ATCM, 2008).

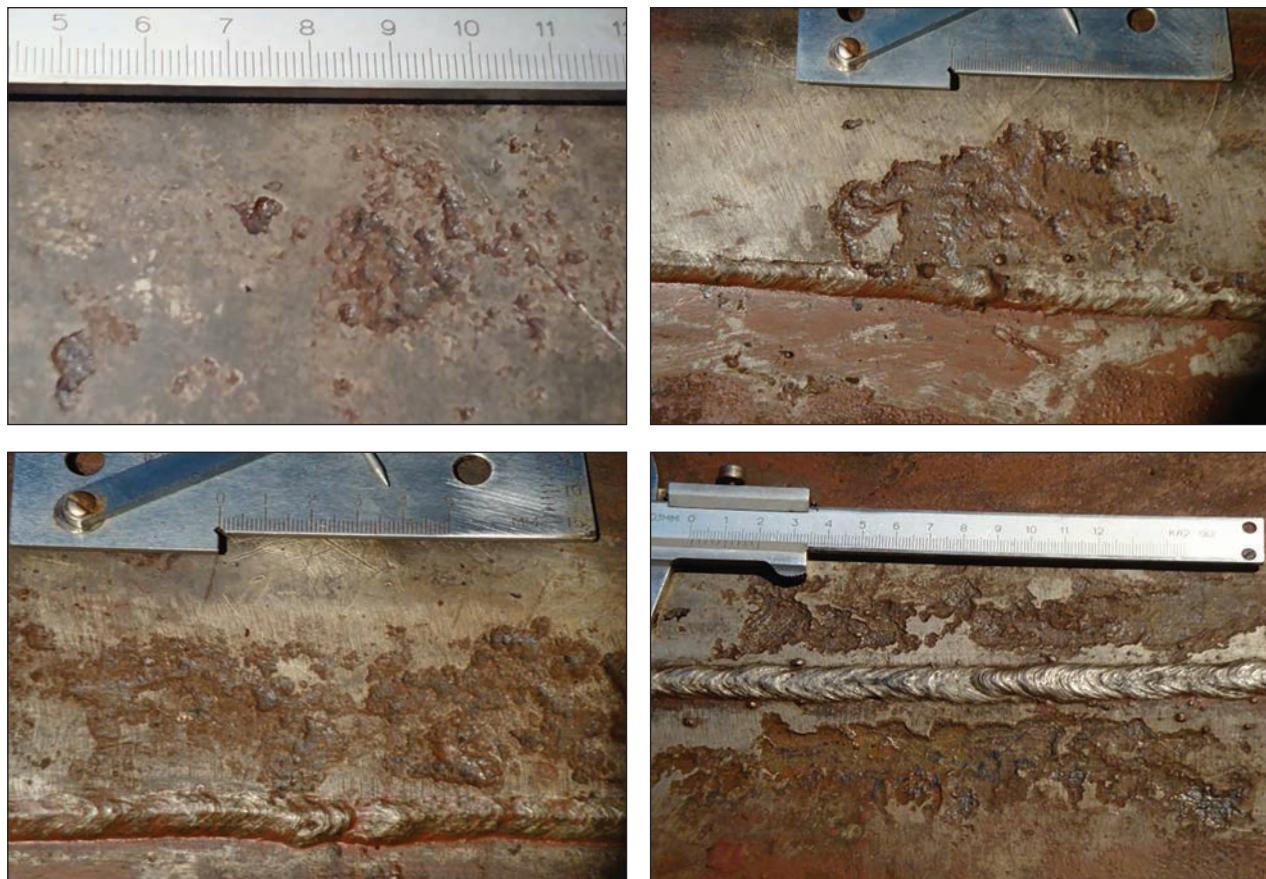
The bottom of the internal tank is made of steel sheets of 5.0 mm to 5.2 mm thickness. The sheets are assembled into strips by butt-welded joints, and the strips are joined together in an overlay. External inspection and visual control of the bottom of the tank showed that the surface of the metal sheets and welded joints were affected by pitting corrosion up to 2.0 mm deep. Corrosion ulcers of different depths are grouped in areas of 20–40 cm² and scattered over the sheets, mainly along the welded joints. The characteristic corrosion impressions of the bottom sheets are shown in the photo in Figure 3.

Figure 3. General view of corrosion damage at the tank's bottom

One of the main conclusions of tank diagnostics was the need for priority anti-corrosion protection of the bottom of the internal tank. Anti-corrosion coating of the bottom was installed in 2019.

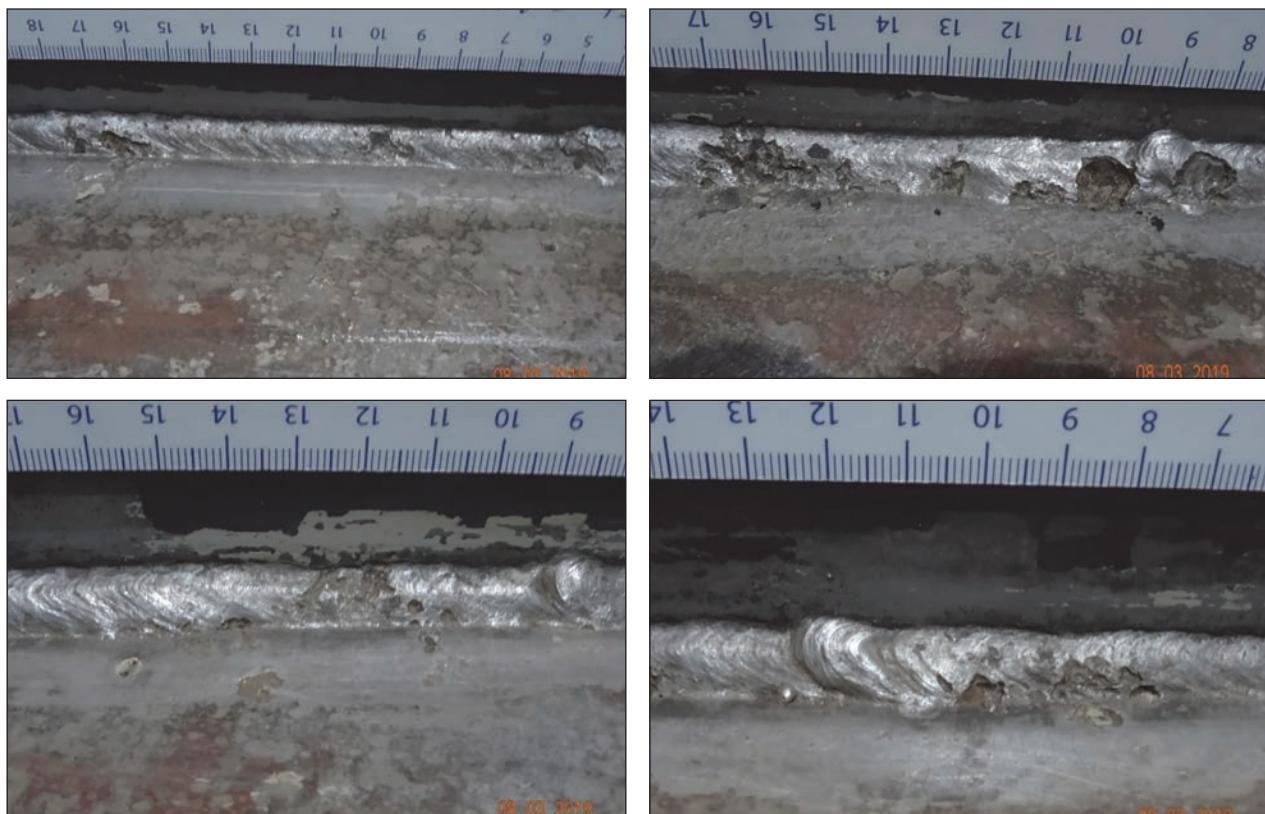
Separate corrosion ulcers with a depth of up to 2.0 mm were also found in the weld seams. There are splashes of metal along the seams. The general appearance of corrosion damage to the bottom welded joints is shown in the photo in Figure 4.

Figure 4. General view of corrosion damage of welded joints at the tank's bottom
