Yu. Posypaiko^{1,*}, A. Andreev²

Monitoring the technical condition of the fuel storage facility at the Ukrainian Antarctic Akademik Vernadsky station

3.1 General characteristics and technical conditions of the VST-200 fuel tank

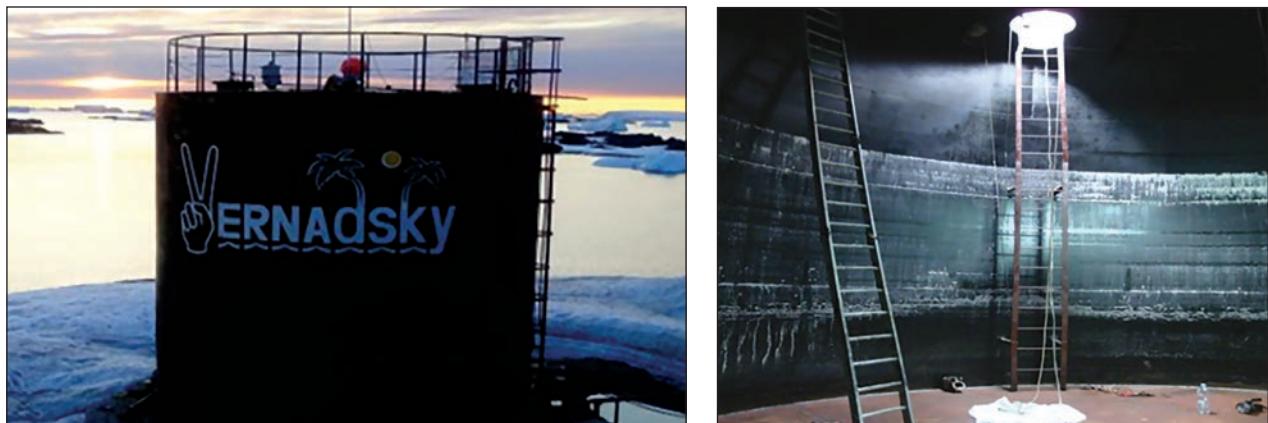
Figure 1. The fuel tank VST-200, outside and inside view

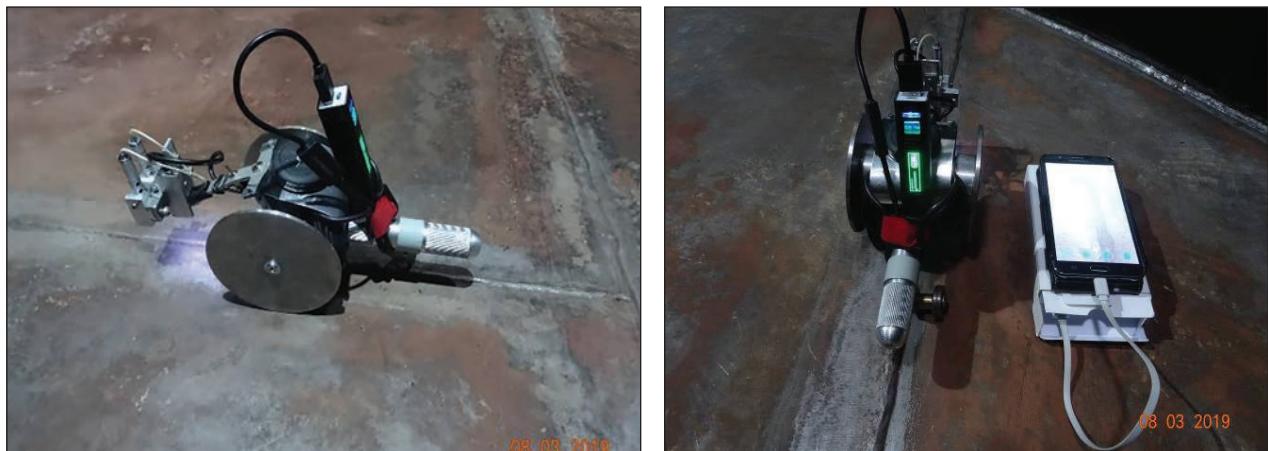
During the examination of the tank's bottom, a test of the VK/TVA-1 visual information recording device was carried out, as shown in Figure 5. The VK/TVA-1 device is equipped with a video camera and a unit for wireless transmission of information to a smartphone. The device allows the examination of the welded joints of tanks and recording visual information about their condition. This information can be transmitted over communication lines to Ukraine to specialists in non-destructive testing for professional analysis using computer equipment in laboratory conditions.

Figure 5. Testing of the VK/TVA-1 visual information recording device on the welded joints at the bottom of the VST-200 tank
